Third Quarterly Report on Manufacturing Methods and Technology Engineering for TFT Addressed Display 2

November 7, 1976 to February 7, 1977

Westinghouse Industrial & Government Tube Division
Westinghouse Circle
Horseheads, New York 14845

CONTRACT DAABO7-76-C-0027

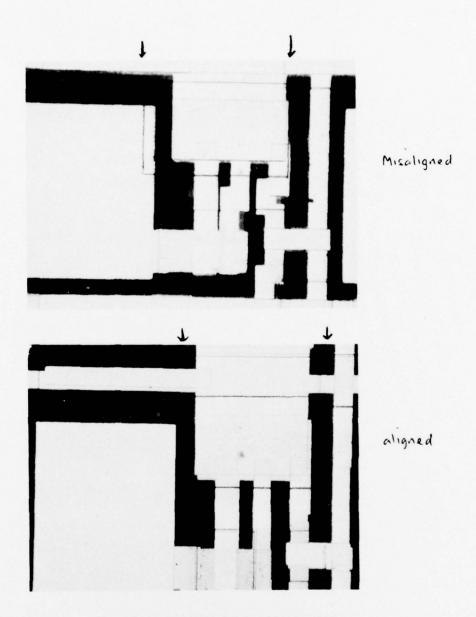
Fig (3) Marginal Alignment in Elemental Capacitor

Examination of thin film patterns revealed that a marginal alignment condition prevailed in the double layer cell capacitor. As shown in Fig (3) in certain specific regions of the circuits the plates were overlapping (very slightly) over the edge of the dielectric. Two factors were thought responsible, lack of mask:mask pattern integrity in this particular mask set or movement of the mask during deposition or operation of the jig. Examination of mask to mask pattern registration revealed that although it could be improved it should be more than sufficient for non-shorted capacitors. A wide tolerance guard band was of course designed in to this pattern. Tests on jigs and masks revealed that the prime cause was inconsistent clamping tension of the mask to the mask holder. A more rigorous procedure was instituted and, as of this report date the problem has not reoccurred.

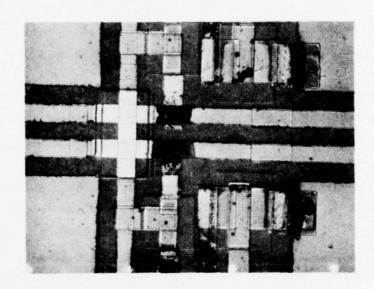
Fig (4) Oxidation Corrosion

One run of four substrates was annealed under the usual conditions and was found to have developed a metallic corrosion problem. After checking anneal oven temperature, location in the oven etc. the problem was clearly pinned down to the tank N_2 supply. A new supplier of nitrogen had been recently introduced (on a site basis) and an analysis of the nitrogen quality was performed. Table (1) shows the result of that analysis compared to the line (house) nitrogen that is usually used in lab operation. The house N_2 is not available to the pilot line; it was decided to anneal the substrate in the lab anneal systems from now on. This itself caused some minor problem since the

Fig (4) shows typical "oxidation" corrosion and Fig (5) shows a typical example of intermetallic corrosion.

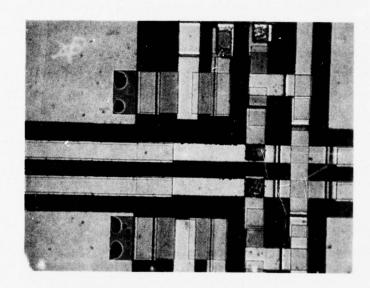
Fig (5) Intermetallic Corrosion

use of the four substrate stacking jig raised the substrates out of the good control zone of the oven. This caused some intermetallic corrosion. With better oven positioning this has now been solved.

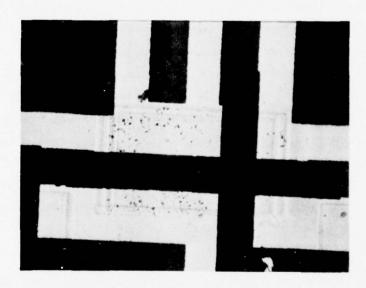
Fig (6) Typical Example of Bad ${\rm Al}_2{}^0{}_3$ Spitting

Another well established cause of short circuits is spits in the aluminum oxide. Much progress has been made in this area but further improvement is needed. Fig (6) illustrates a dielectric badly contaminated with spits.

Early this period, the primary remaining cause of ${\rm Al}_2{\rm O}_3$ "spitting" was tentatively identified: flakes of ${\rm Al}_2{\rm O}_3$ peel off surfaces above the electron-beam gun during evaporation, fall into the hot crucible, and re-evaporate explosively. This observation was reinforced when thermal shields within the electron-beam gun well were relocated so that all surfaces were clear of the area above the crucible. The only major remaining source of peeling was the mask wheel. Past efforts to prevent peeling by roughing the stainless steel surface by wire brushing or sanding only made the problem worse, indicating that this work was creating a smoother, rather than a rougher, surface. Sandblasting the

wheel was out of the question because of its size, delicate cam adjustments, and cracks and crevices which could not easily be cleaned. The solution was another molybdenum baffle, removable for sandblasting, located approximately 1/8" below the wheel, and covering all surface areas except the mask itself. Since the addition of this baffle, two runs (7 substrates) have been processed and inspected, and virtually all $\mathrm{Al}_2\mathrm{O}_3$ films have been found to have much reduced spec counts. Clearly, cleanliness of the gun wells is critical.

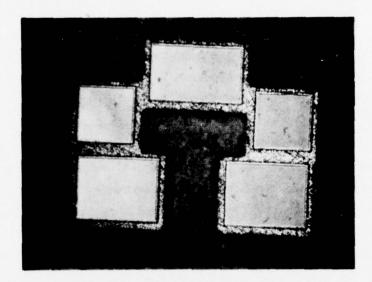
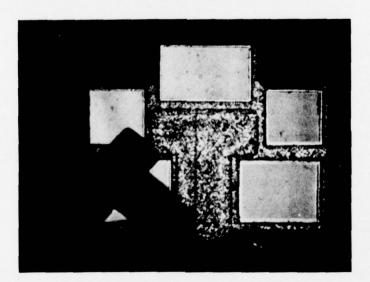
Fig (7) Mask Bridge Peeling

A troublesome but minor problem has been "lifting" off the nickel underside "bridge" in one of the dielectric masks. Fig (7) illustrates a good and bad "bridge." The lifting was found to be a problem associated with mask cleaning and was only significant with the thinner (3.7 mil) masks. The usual (5.5 mil) masks were not troublesome in this respect. We have now standardized on the thicker mask.
